Subject: Lower Plum Creek WS SCS Site 38 Dam – TX04369
Caldwell County
Dam Safety Inspection Report

DAM SAFETY INSPECTION REPORT

INVENTORY No.: TX04369

DAM: Lower Plum Creek WS Site 38 Dam

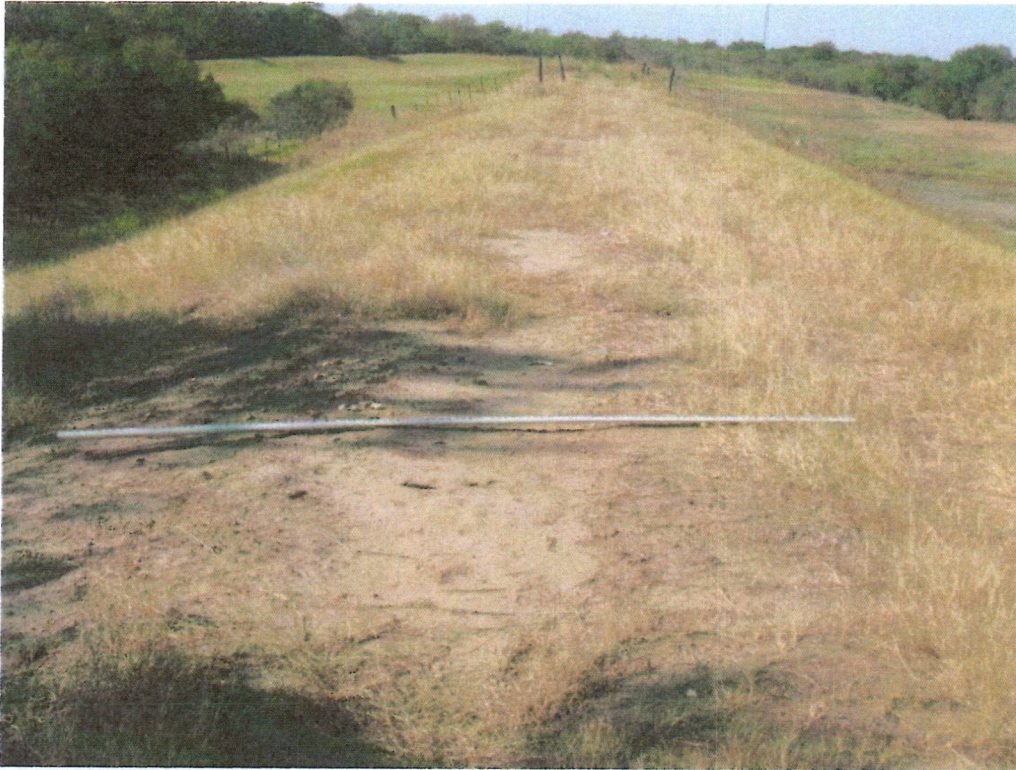
- The dam crest has a length of approximately 1,485 feet using aerial photography and the crest width was measured during the inspection to be 14 foot wide.
- The crest was found to be in good condition, however, there were several areas with no grass cover. See photographs 1 and 2.

Photograph 1. Crest looking right. Note bare spots.

5. The bare spots on the crest and bare strip on the downstream slope should be reseeded to prevent further erosion, as shown in photographs 1 and 5, respectively. Discuss a grazing plan with the landowner(s) to restrict livestock from these areas while the new grass takes root.
6. The excess vegetation within the upstream slope riprap should be sprayed with an approved herbicide or removed to facilitate future inspections. See photograph 4.
7. The low flow (or 'drain') valve should be exercised at least on an annual basis to ensure it is in good working order and capable of lowering/draining the reservoir should an emergency situation ever warrant such.

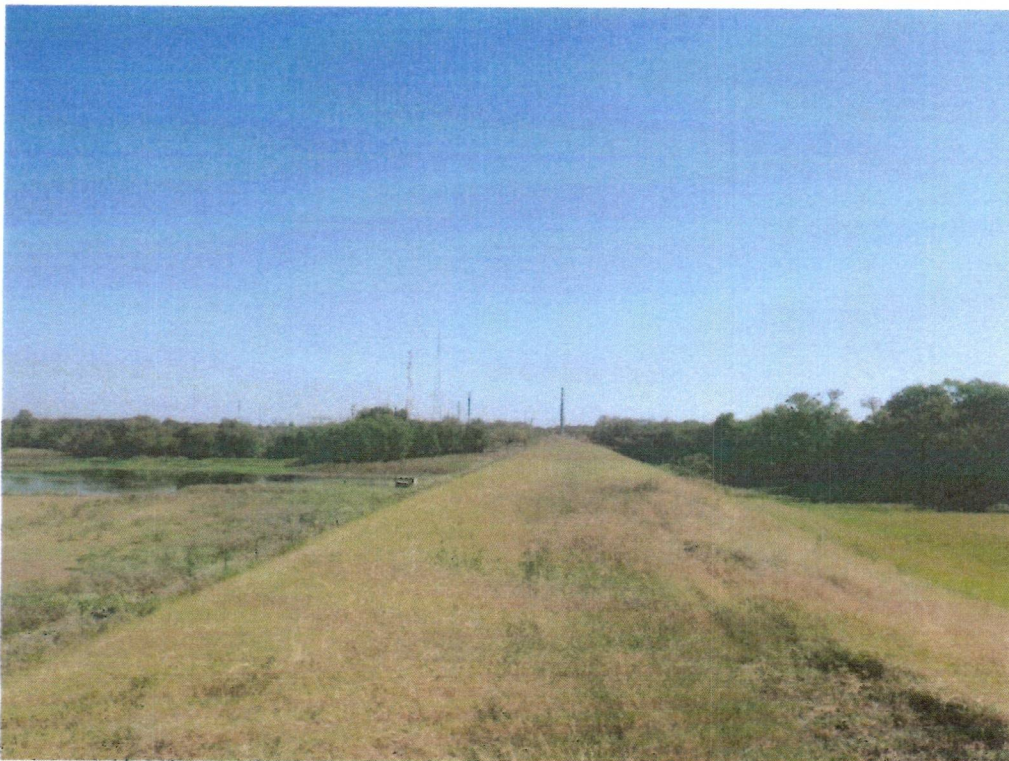
Photograph 2. Crest looking left.

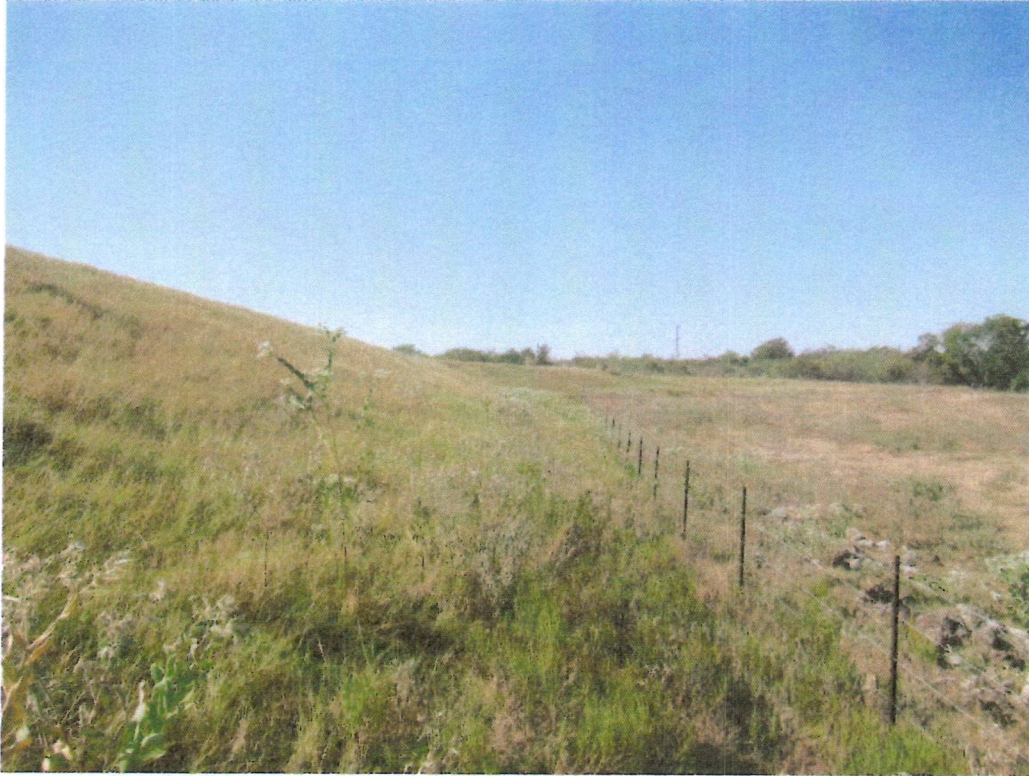
- The 2.5 horizontal to 1 vertical [2.5H:1V] upstream slope of the earthen embankment was covered with grass, and the grass was of sufficient density.
- The upstream riprap was performing well, and no excessive erosion was noted, however, there was significant vegetation growing within the riprap.
- The upstream slope was found to be in good condition.
- See photographs 3 and 4.

Photograph 3: Upstream looking right.

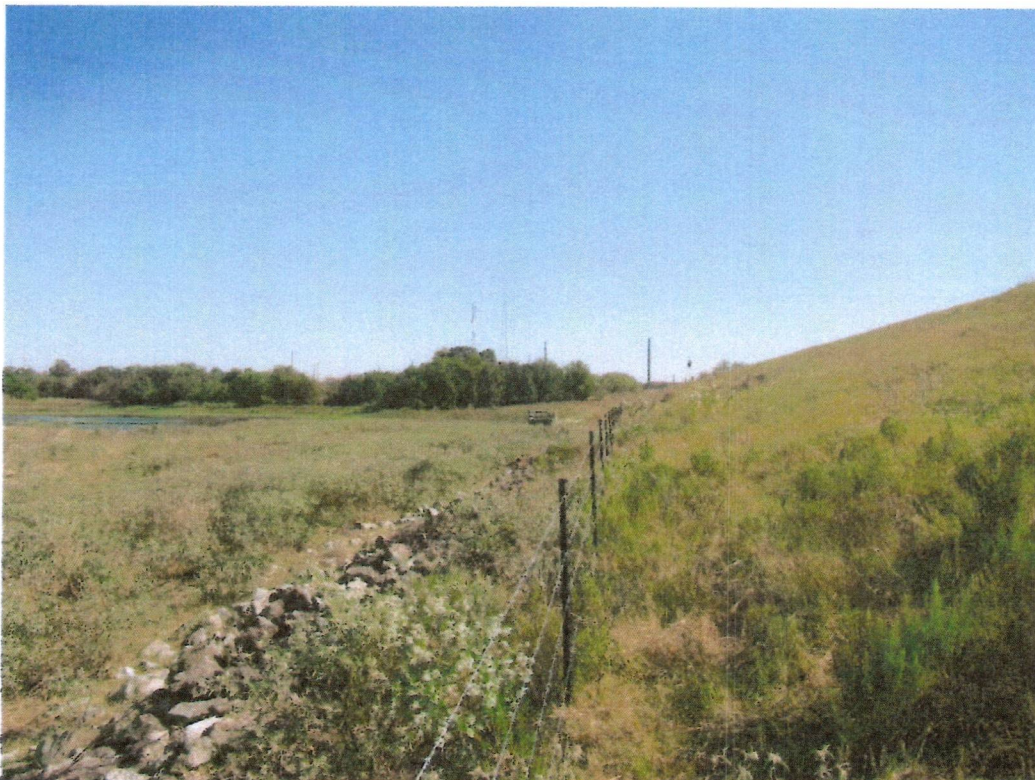
Photograph 4: Upstream looking left. Note vegetation among riprap.

- e. Appendix C of the *Guidelines for Operations and Maintenance of Dams in Texas* discusses possible pre-emergent herbicides (acceptable for use near reservoirs) for use on the vegetation covered upstream slope riprap.

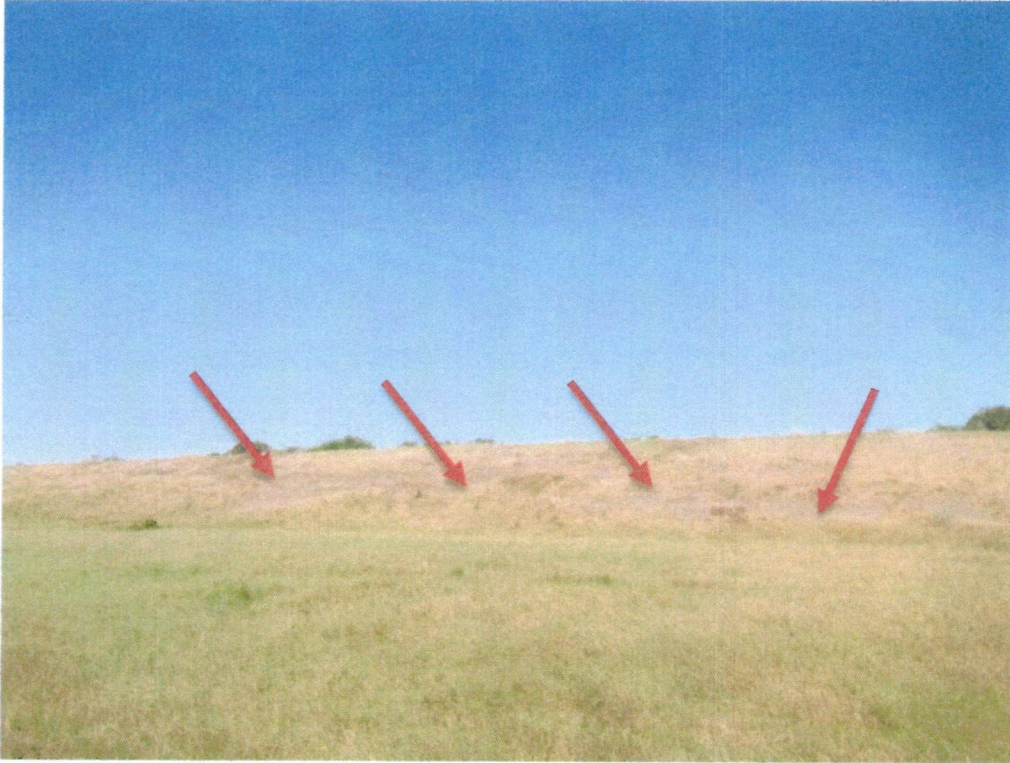
- The 2.5H:1V downstream slope of the earthen embankment was covered with grass except for a bare strip located at the right end of the embankment approximately 280 ft. from the principal spillway.
- The downstream slope was found to be in fair condition.
- See photograph 5.

Photograph 5: Downstream slope with bare spots.

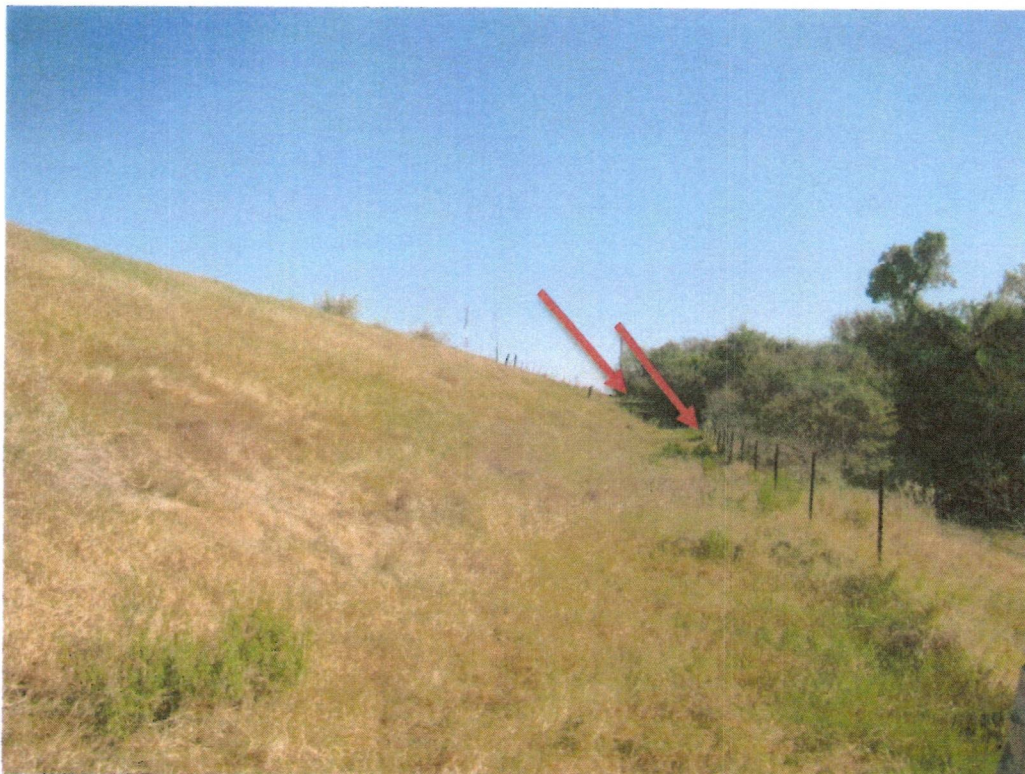
Photograph 6: Downstream slope looking left.
Note brush new toe area.

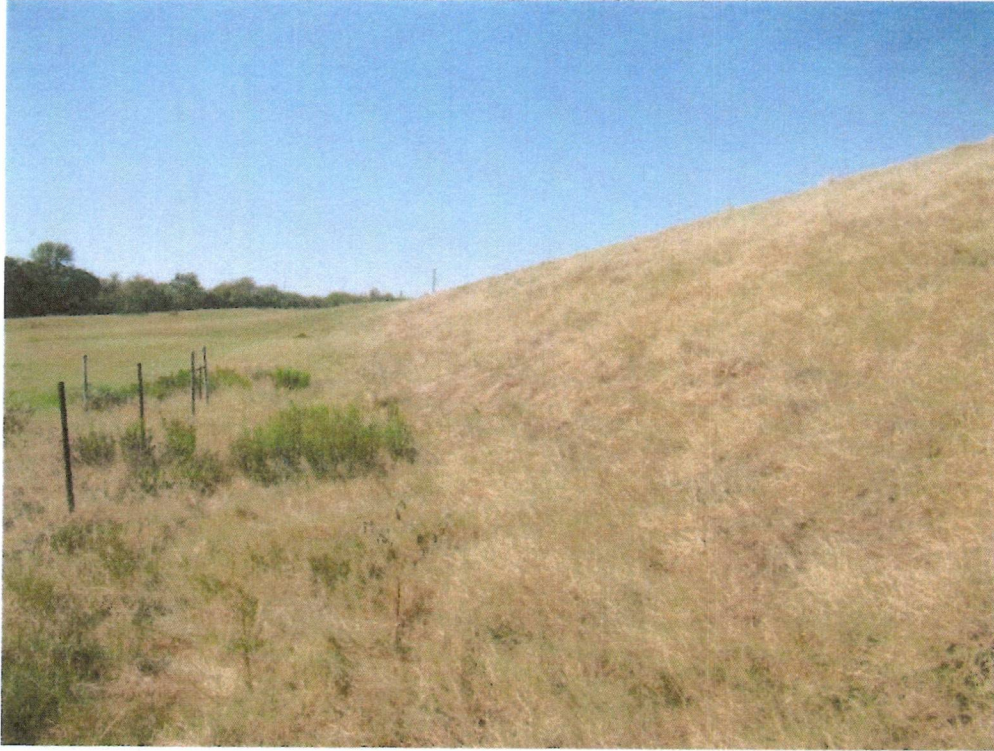
Photograph 7: Downstream slope looking right.

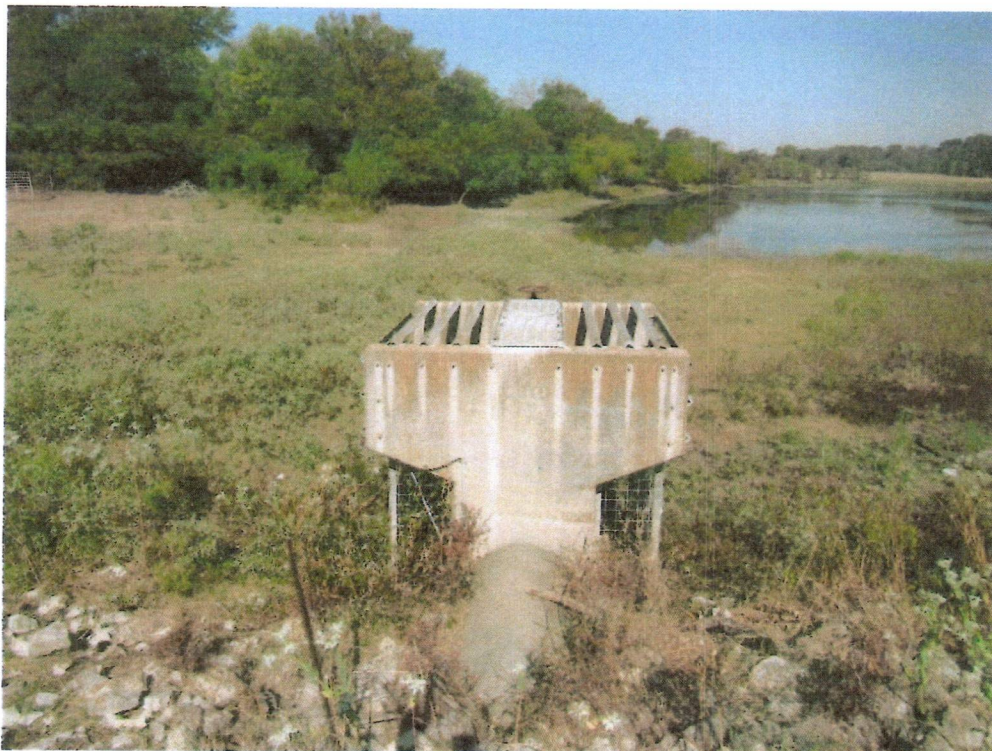
- The principal spillway consists of an open top rectangular riser with a 2.5 ft. by 7.5 ft. drop inlet with invert height of 6 ft. The spillway drop inlet had four 2.5 ft. by 1 ft. ungated inlet ports (two on each side).
- The 190 ft. long 2.5 ft ID prestressed, concrete lined steel cylinder discharge outlet pipe was in fair condition, however, there was spalling at the end of the pipe and pipe joint sealant degradation. Both appeared to be repaired in the past.
- There were two 6-inch toe drain pipes bolted to the base of the outlet cantilever. The toe drains were dry and not flowing. The pipes were found in good condition.
- The spillway was found to be in good condition.
- See photographs 8, 9, 10, 11 and 12.

Photograph 8: Principal Spillway inlet and reservoir.

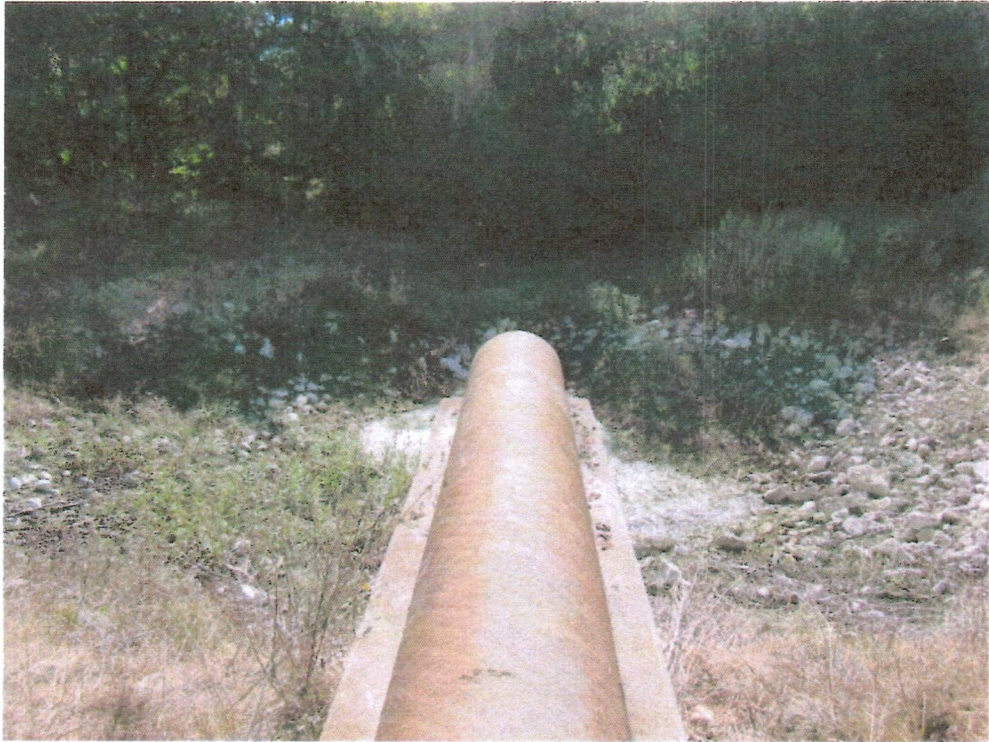
- The channel downstream of the plunge pool contained trees and brush that have the potential to restrict flow from the plunge pool.
- See photograph 9.

Photograph 9: Principal Spillway outlet pipe and plunge pool.

- a. Monitor on a regular basis the spalling and pipe joint sealant degradation at the discharge outlet pipe until repairs are made.
- b. Monitor on a regular basis the plunge pool discharge flow to ensure it is not restricted excessively. If the flow is restricted then clear a path for the discharge.

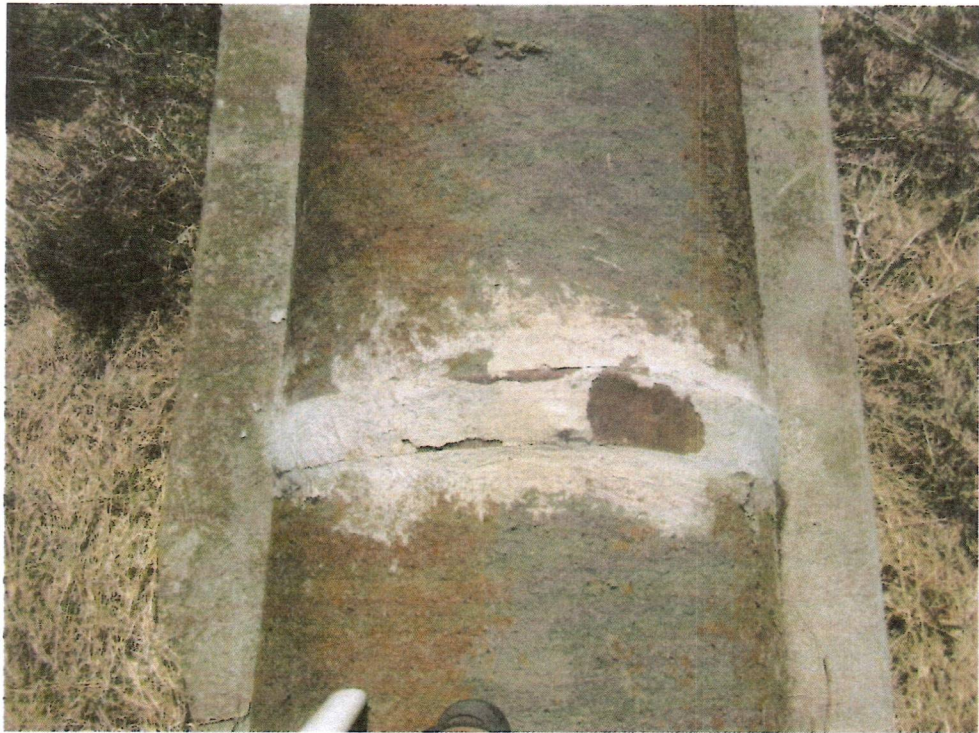
Photograph 10: Principal Spillway outlet pipe sealant degradation.

If conditions worsen with any of the deficiencies, then a Texas Licensed Professional Engineer (PE) should be consulted to determine the level of damage and recommend repairs/improvements, if needed.

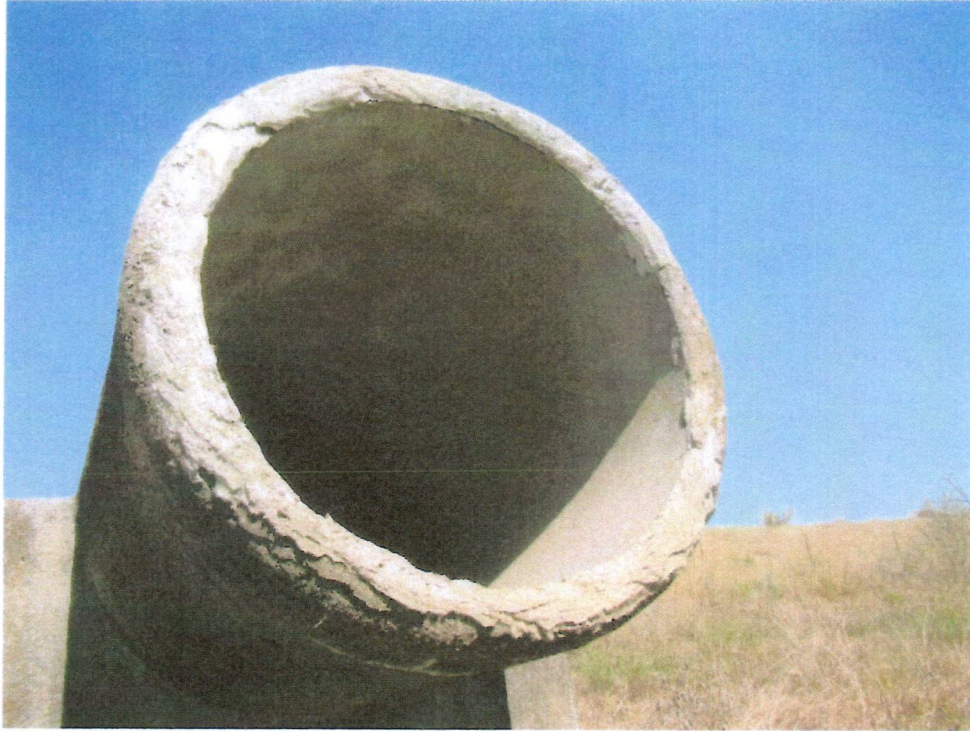
Photograph 11: Spalling at outlet pipe discharge.

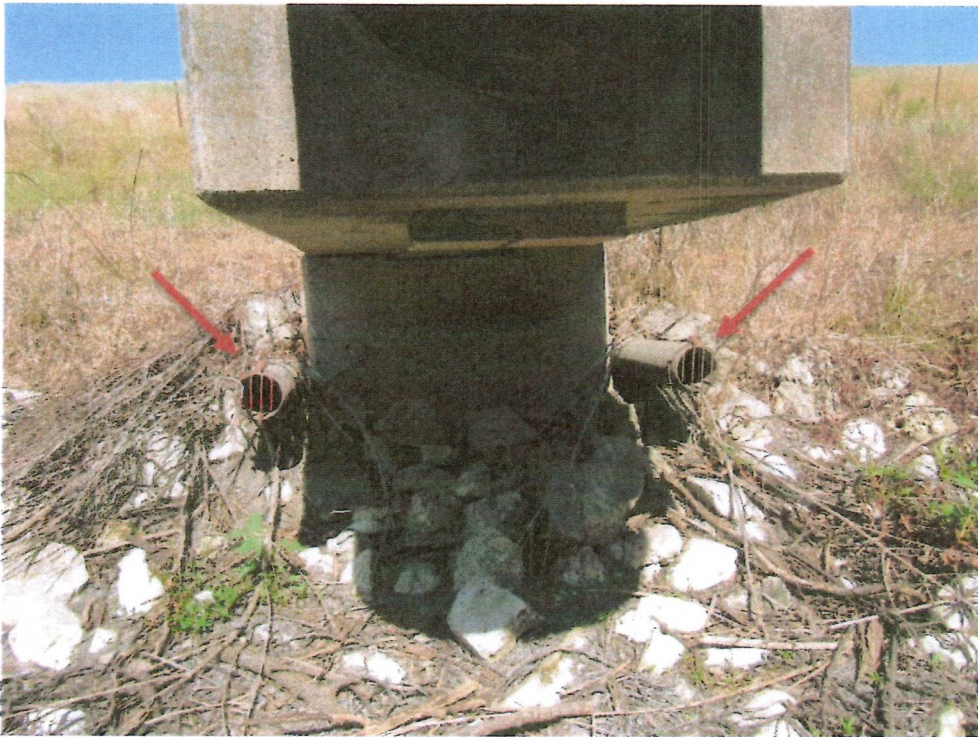
Photograph 12: Toe drain outlets.

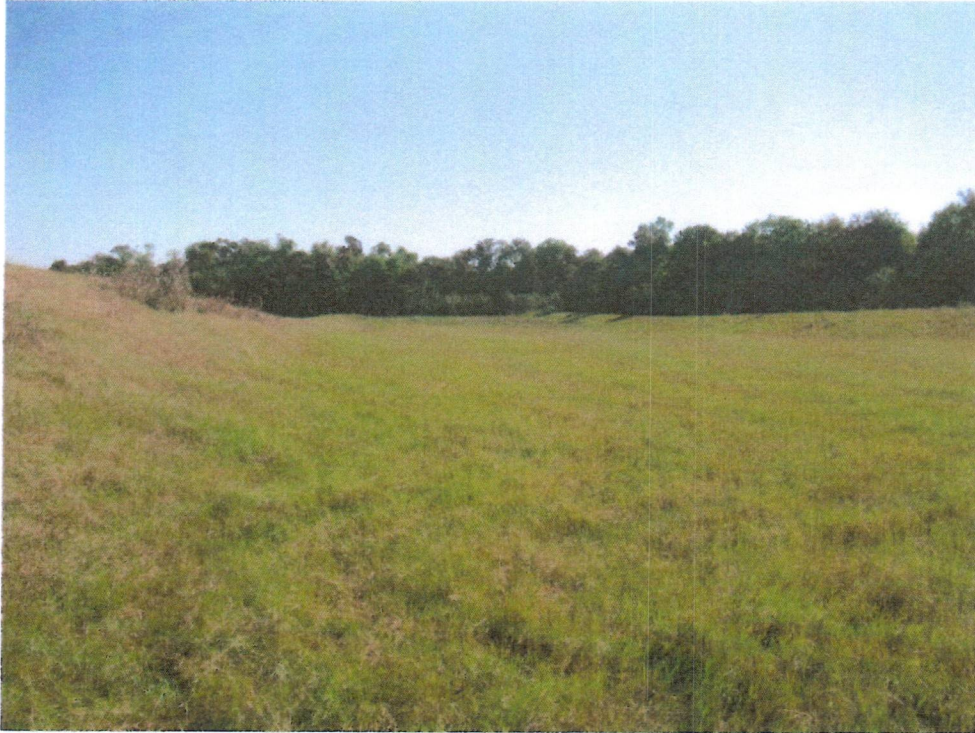
- The emergency spillway, located at the right (southwest) side of the dam, was found to be in good condition.
- Per the NRCS as-built plans, the spillway is a 150 ft wide earthen channel with a control elevation of 340.6 ft-msl. It was found with mostly grass and small weed cover.
- See photograph 13.

Photograph 13: Emergency Spillway.

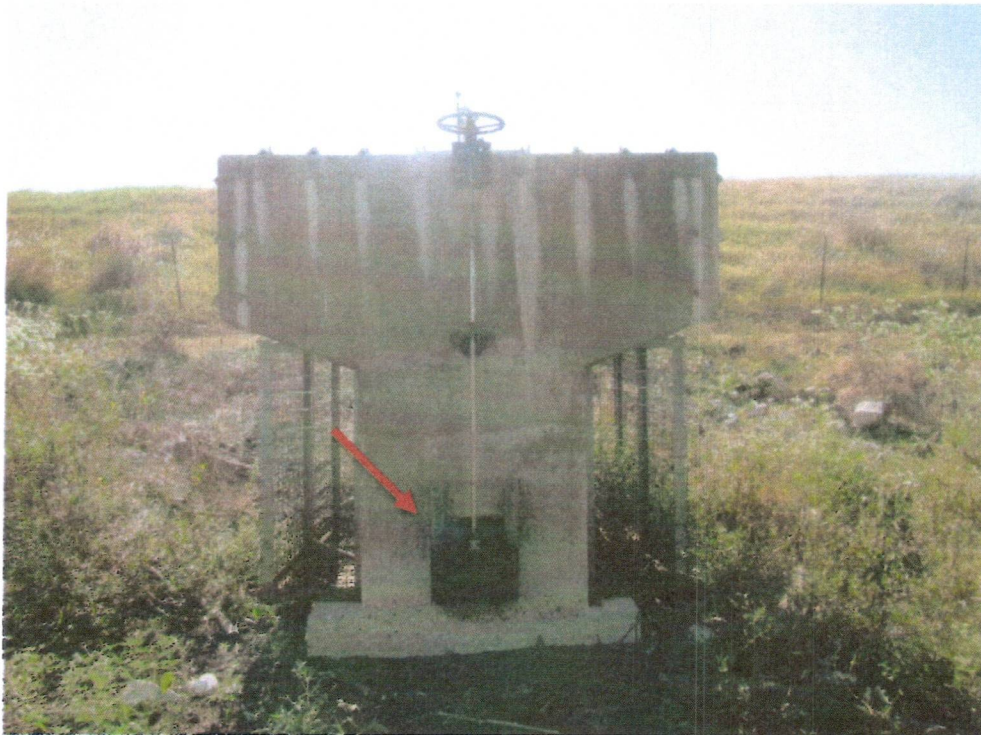
- Via email, Alan Burklund of the PCCD, stated the low flow outlet valve is exercised annually. The valve was last inspected and exercised on July 19, 2024.
- The 12-inch gated low flow outlet valve is located at the bottom of the principal spillway.
- The low flow outlet was found to be in good condition.
- See photograph 14.

Photograph 14: Low flow outlet valve.

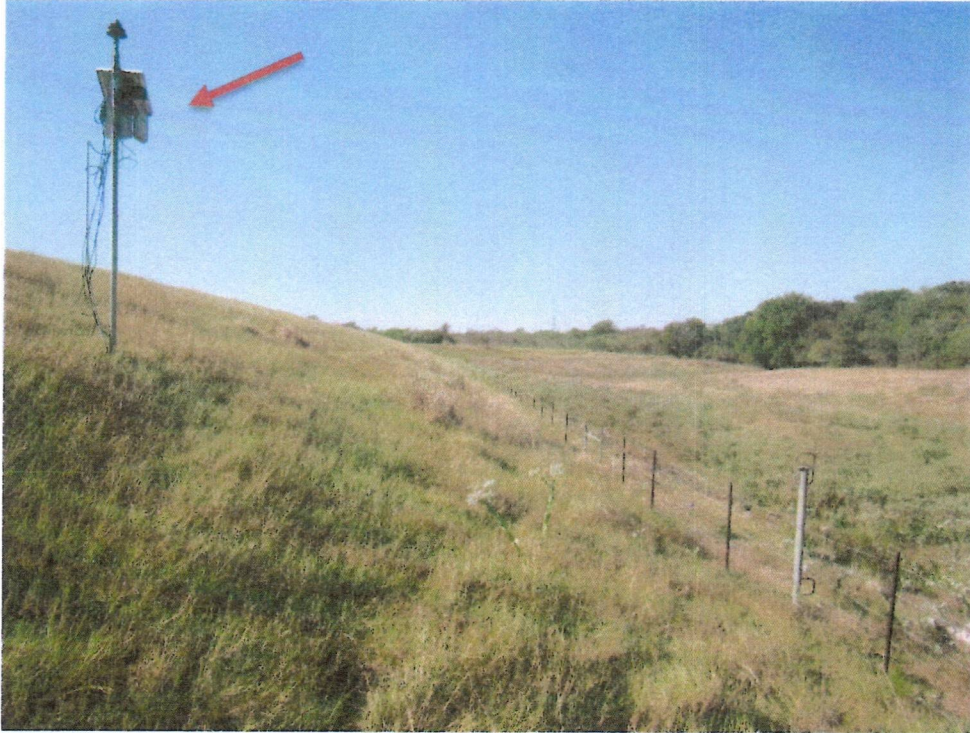
- Via email, both Alan Burklund and Daniel Meyer indicated the weather station instrument located on the upstream slope is out of service. The instrument used to measure precipitation and reservoir level.
- See photograph 15.

Photograph 15: Out of service weather station.
